# Residential apartment, Tower-final QA and handover snag list

Job Reference: US-F033-NYC

Project: Residential apartment,  
Tower-final QA and  
handover snag list

Location: 845 8th Avenue, New  
York NY 10019, USA

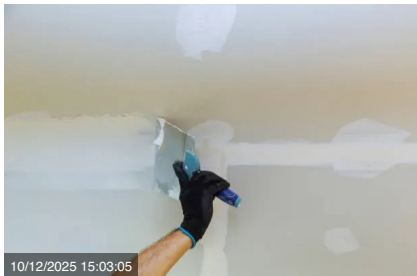
## Ceiling Patch Marks Visible After Repair

The false ceiling shows patchy texture where repair work was carried out. Needs surface sanding and uniform repainting for a smooth finish.

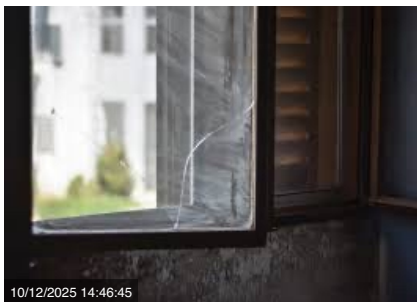
## Bedroom Window Glass Scratched

Sliding glass panel has visible scratches affecting clarity. Replace the damaged panel and verify frame alignment after installation.

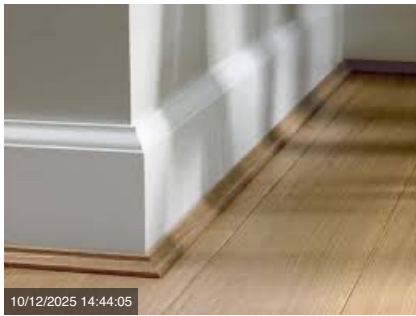
## Missing Skirting Board in Living Room

Skirting strip missing along the wall behind sofa placement. Needs installation of matching finish skirting and proper adhesive fixing

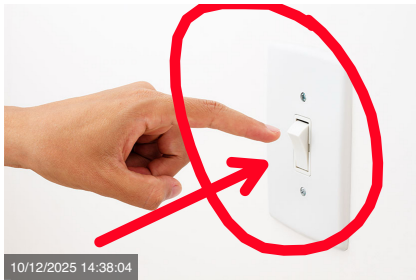
## Electrical switch not working

Bedroom switch for ceiling light is non-operational. Possible wiring fault behind switchboard. Requires continuity test and replacement of switch if defective.

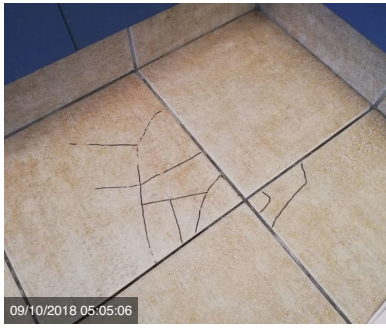
## Cracked Floor Tile Near Kitchen Entry

One ceramic tile at the kitchen threshold is cracked, likely due to impact during installation. Tile must be replaced and grout color matched.

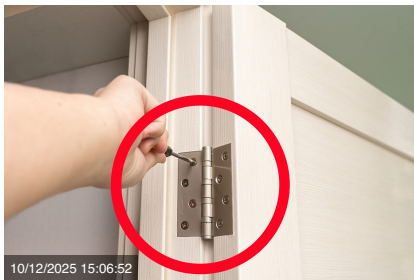
### Main Door Not Aligned Properly

The main door rubs against the frame and does not latch smoothly. Hinges appear loose and need realignment. Replace rubber beading if required.
