# Residential apartment, Tower-final QA and handover snag list

Job Reference: US-F033-NYC  
Start Date: 06/15/2025

Auditor Name: Jason Patel  
Auditor Company Name: Urban QA services LLC

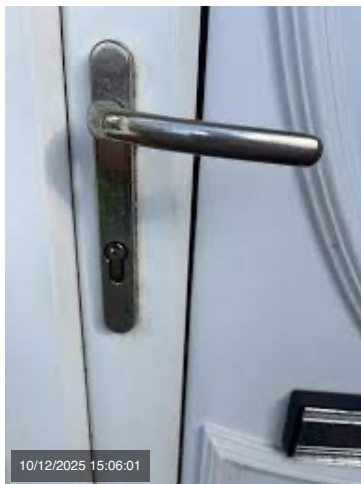
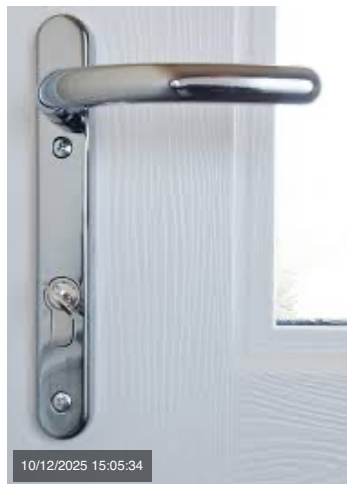
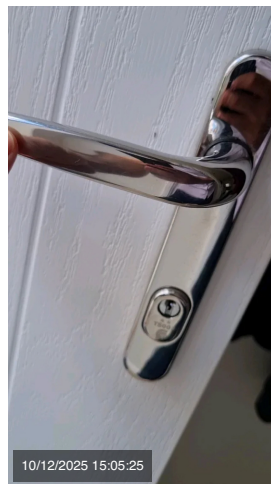
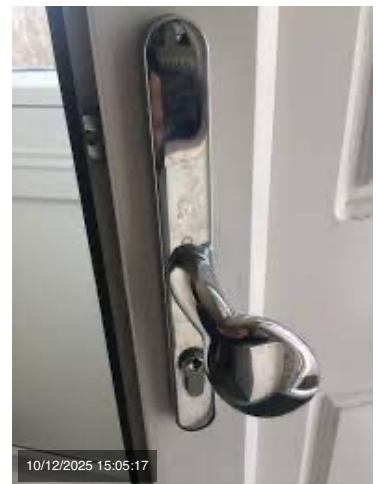
## Wardrobe Handle Loose and Wobbling

The metal handle on wardrobe door is loose, causing improper grip. Tighten screws or replace hardware to match existing finish.

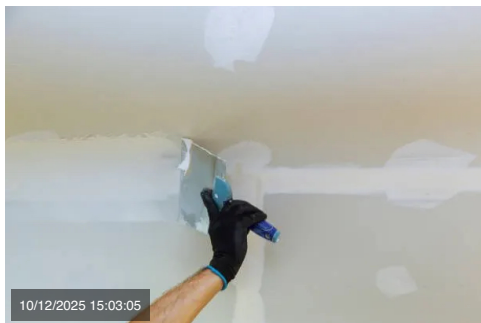
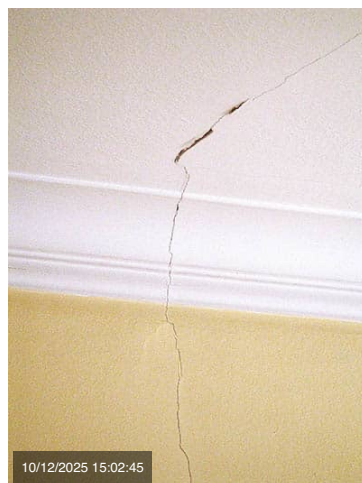
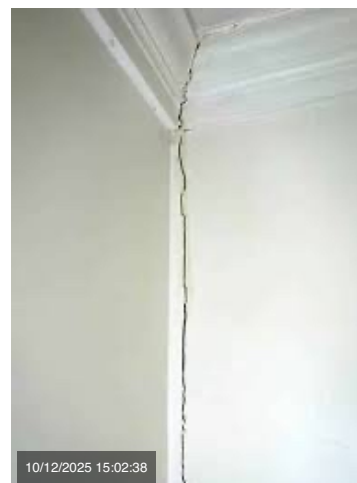
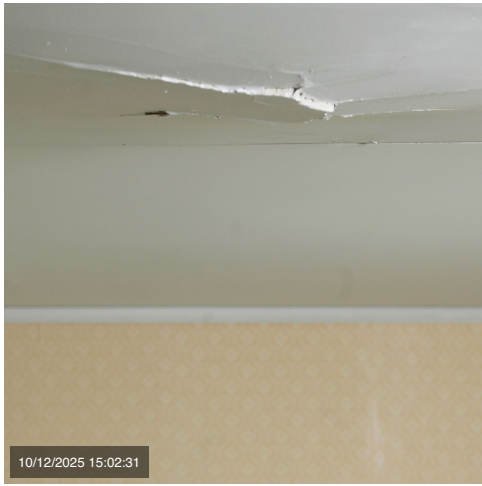
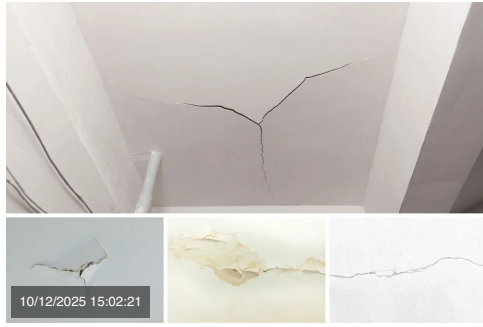
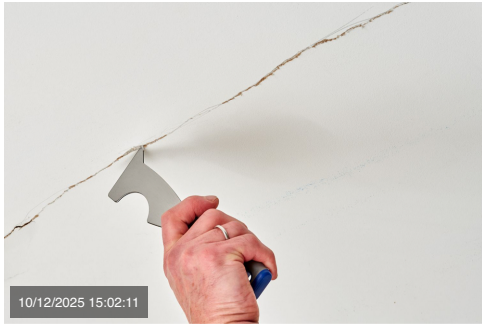
## Ceiling Patch Marks Visible After Repair

The false ceiling shows patchy texture where repair work was carried out. Needs surface sanding and uniform repainting for a smooth finish.

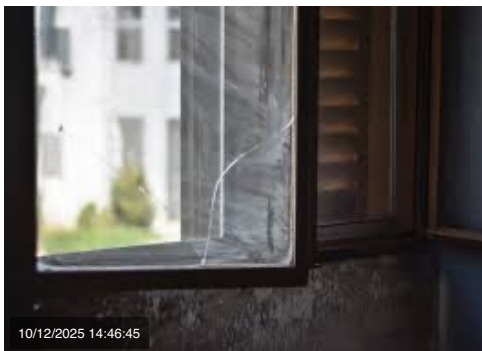
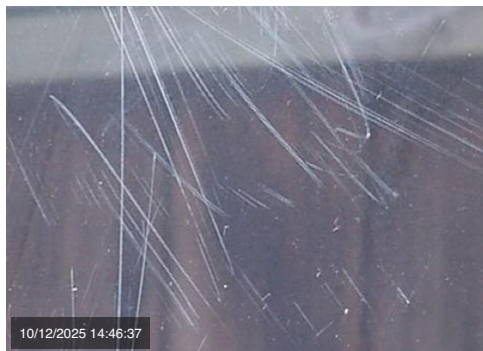
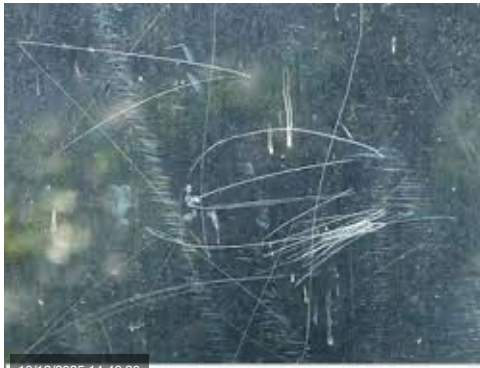
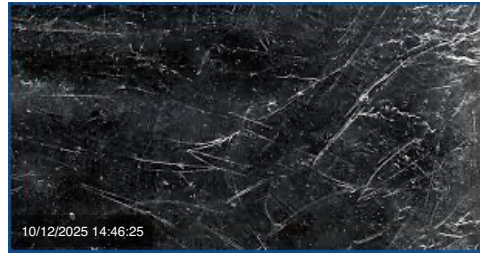
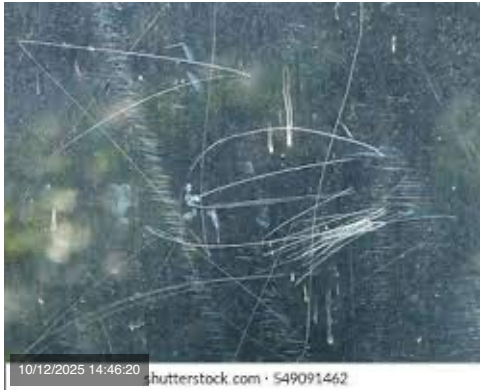
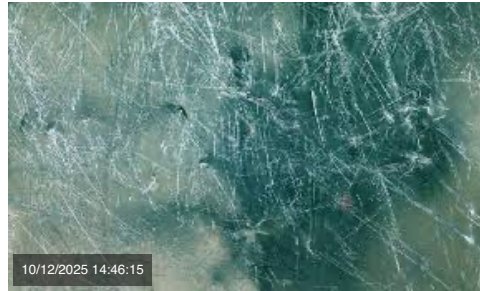
## Bedroom Window Glass Scratched

Sliding glass panel has visible scratches affecting clarity. Replace the damaged panel and verify frame alignment after installation.

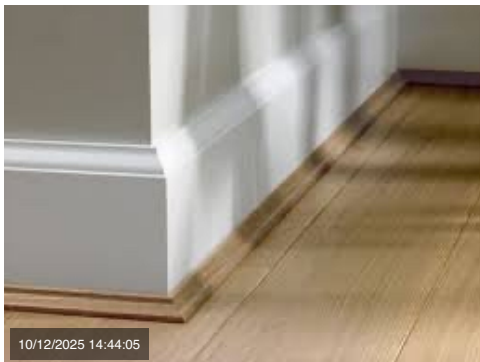
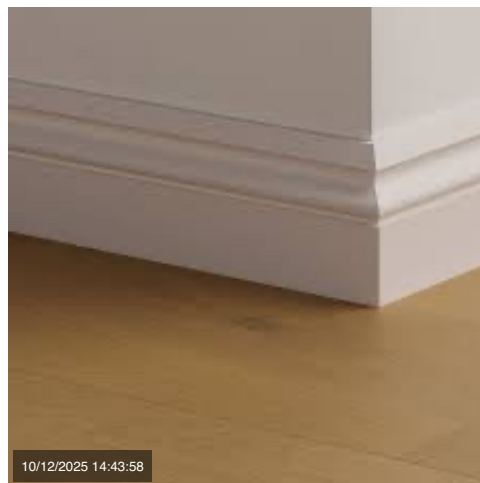
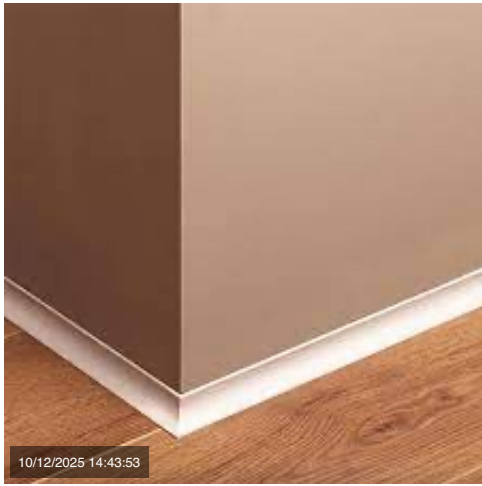
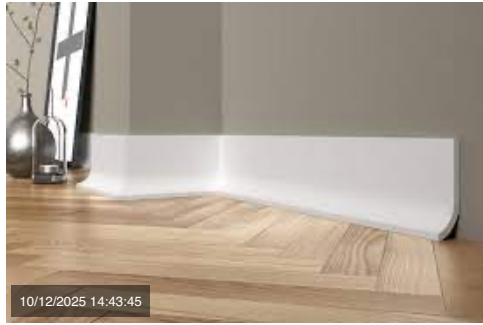
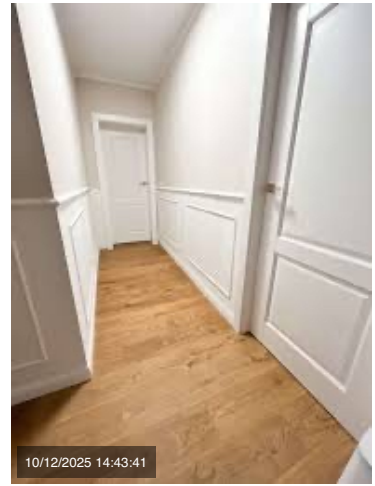
### Missing Skirting Board in Living Room

Skirting strip missing along the wall behind sofa placement. Needs installation of matching finish skirting and proper adhesive fixing

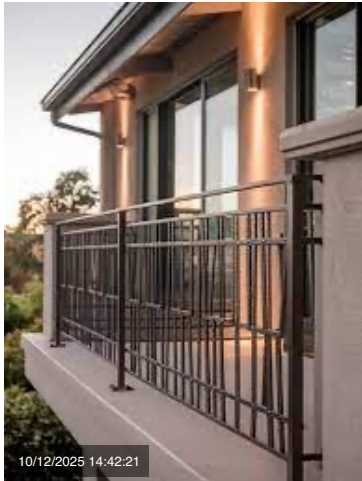
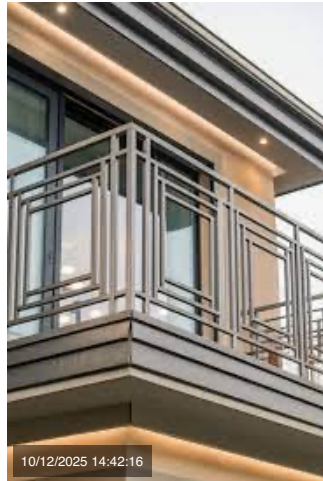
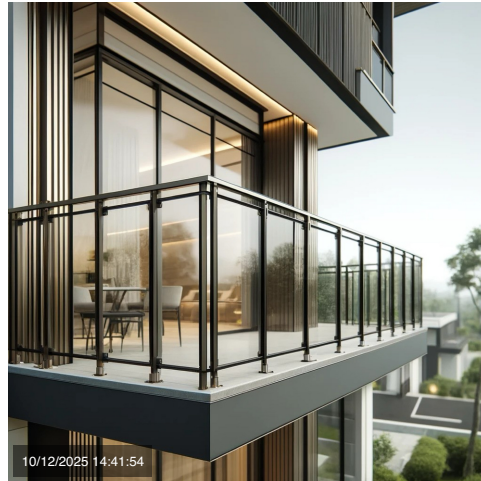
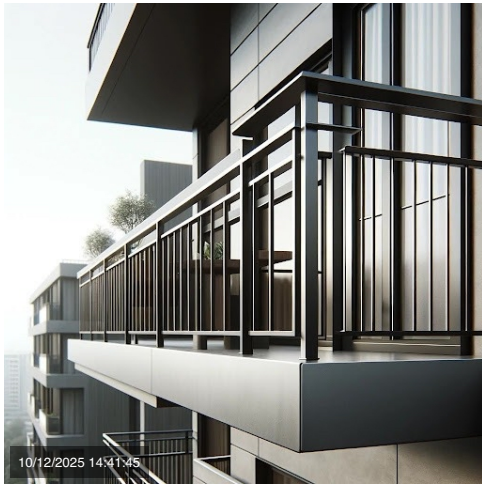
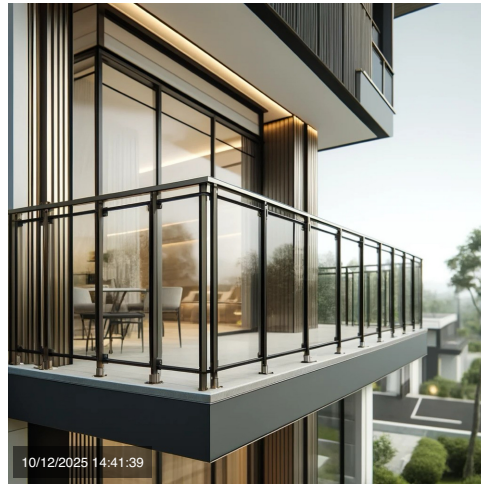
### Balcony Railing Found Loose

Balcony railing slightly shakes when leaned on. Base anchoring bolts need tightening and rust protection coating. Safety check mandatory before handover.

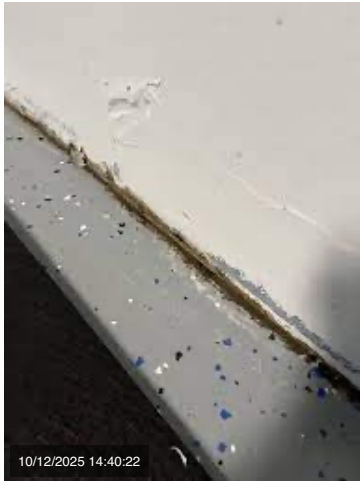
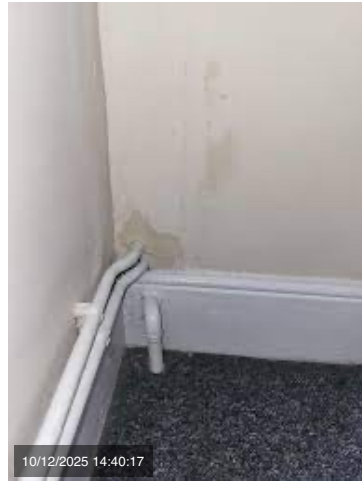
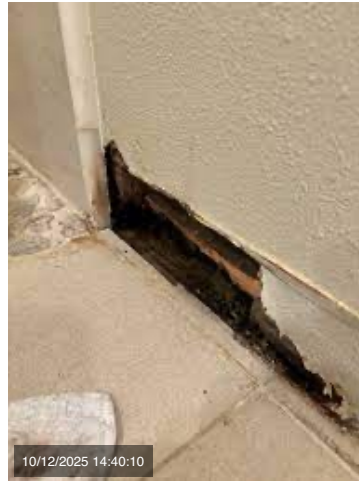
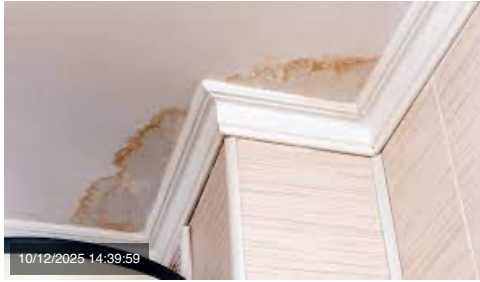
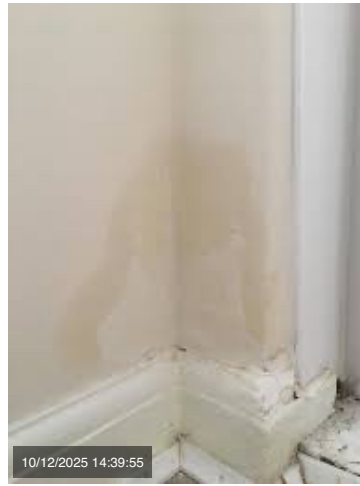
#### Water Leakage Behind Bathroom Wall

Damp patch observed behind WC area. Suspected leakage from concealed plumbing line. Wall needs inspection, rectification, and retiling after repair.

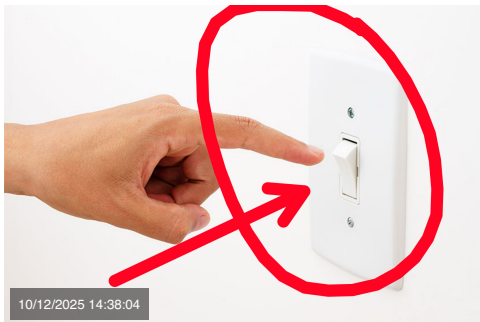
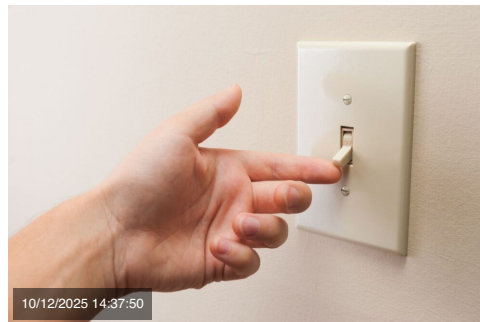
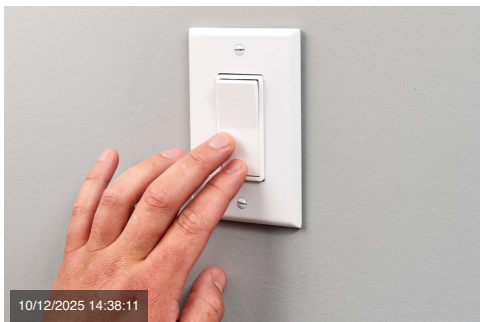
#### Electrical switch not working

Bedroom switch for ceiling light is non-operational. Possible wiring fault behind switchboard. Requires continuity test and replacement of switch if defective.

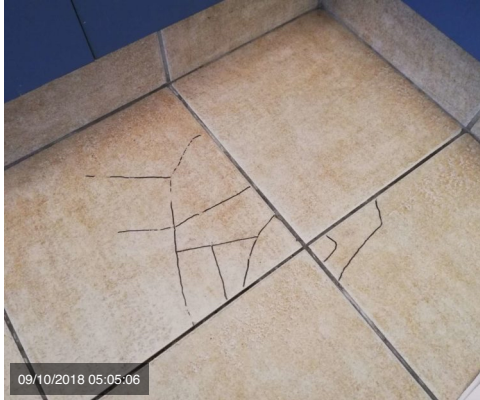
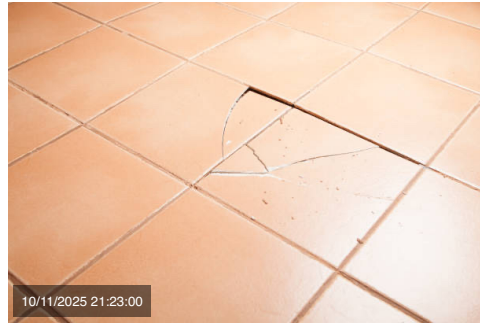
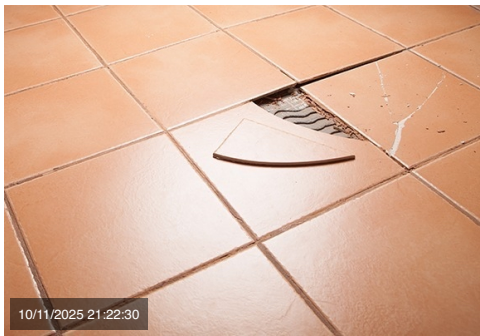
### Cracked Floor Tile Near Kitchen Entry

One ceramic tile at the kitchen threshold is cracked, likely due to impact during installation. Tile must be replaced and grout color matched.

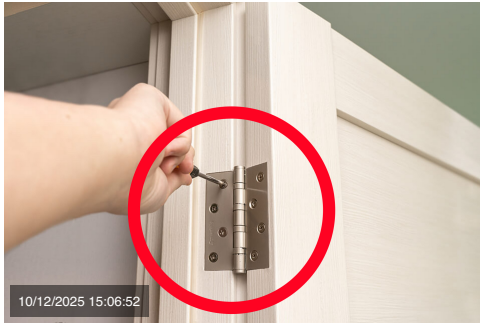
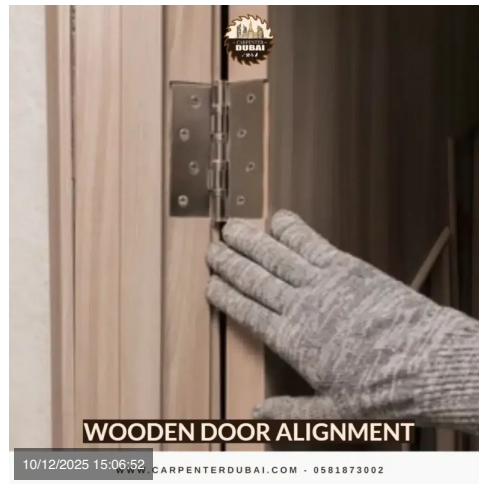
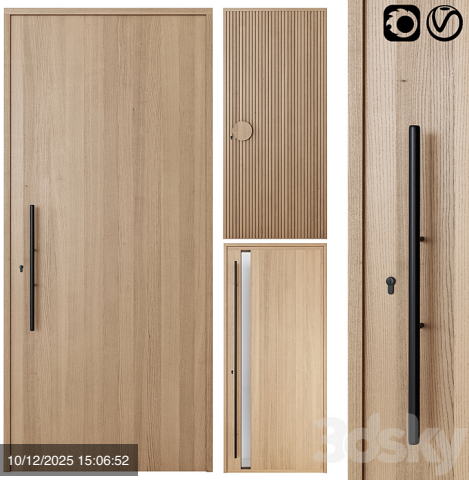
### Main Door Not Aligned Properly

The main door rubs against the frame and does not latch smoothly. Hinges appear loose and need realignment. Replace rubber beading if required.

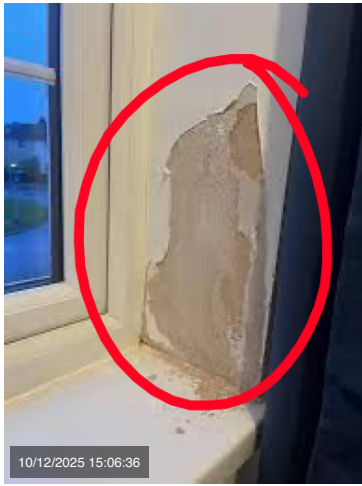
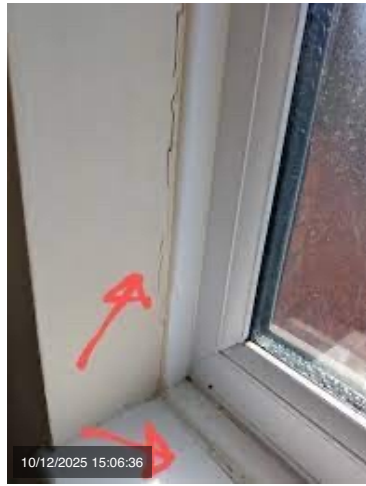
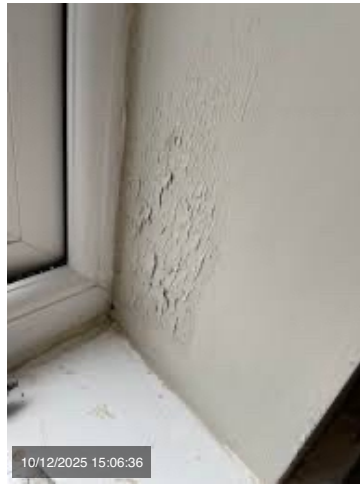
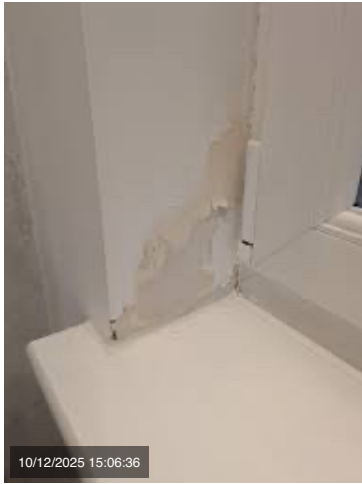
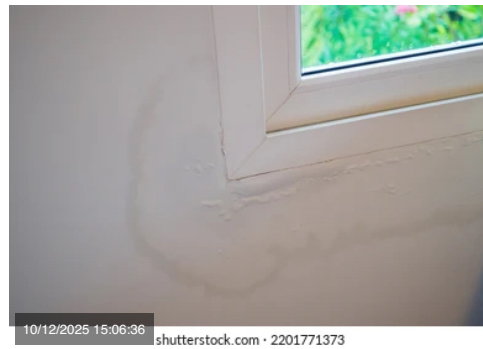
Wall Paint Peeling Near Window Frame

The emulsion paint is peeling off near the living room window, exposing the primer surface. Possible moisture seepage from outer wall detected. Needs repaint and waterproofing check.
