# Residential apartment, Tower-final QA and handover snag list

Job Reference: US-F033-NYC

Location: 845 8th Avenue, New  
York NY 10019, USA

Total Snags: 10

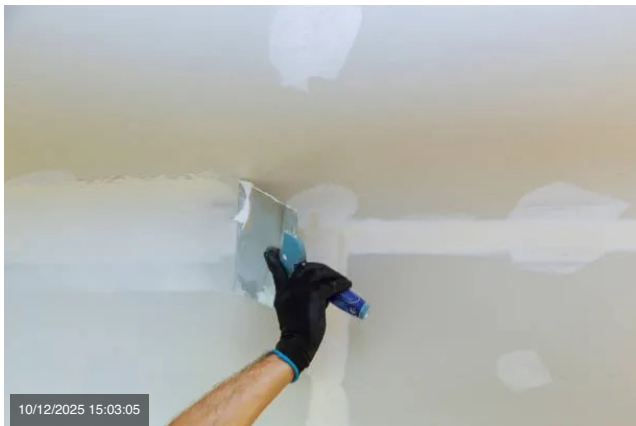
## Ceiling Patch Marks Visible After Repair

The false ceiling shows patchy texture where repair work was carried out. Needs surface sanding and uniform repainting for a smooth finish.

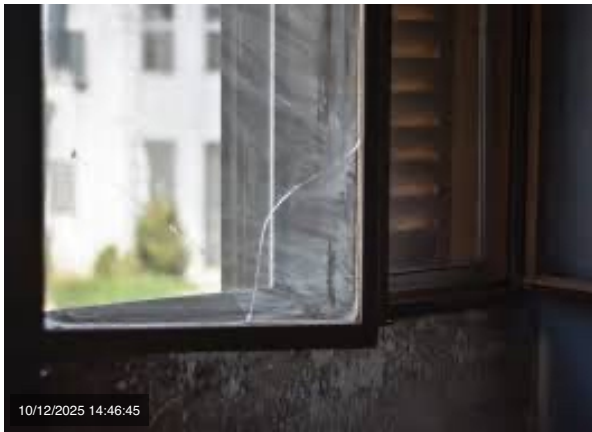
## Bedroom Window Glass Scratched

Sliding glass panel has visible scratches affecting clarity. Replace the damaged panel and verify frame alignment after installation.

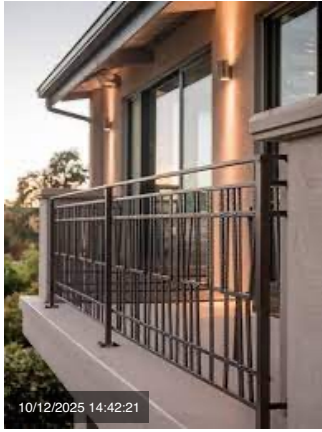
## Balcony Railing Found Loose

Balcony railing slightly shakes when leaned on. Base anchoring bolts need tightening and rust protection coating. Safety check mandatory before handover.

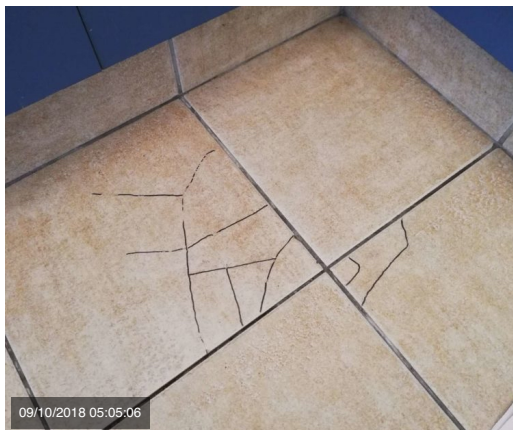
## Cracked Floor Tile Near Kitchen Entry

One ceramic tile at the kitchen threshold is cracked, likely due to impact during installation. Tile must be replaced and grout color matched.

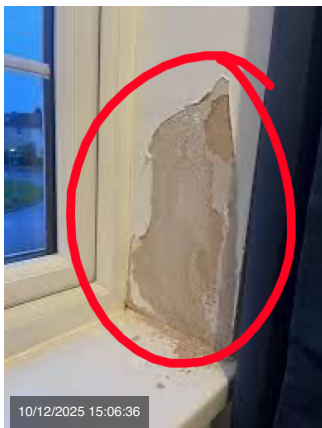
## Wall Paint Peeling Near Window Frame

The emulsion paint is peeling off near the living room window, exposing the primer surface. Possible moisture seepage from outer wall detected. Needs repaint and waterproofing check.
