# Residential apartment, Tower-final QA and handover snag list

Job Reference: US-F033-NYC

Start Date: 06/15/2025

Auditor Company Name: Urban QA services LLC

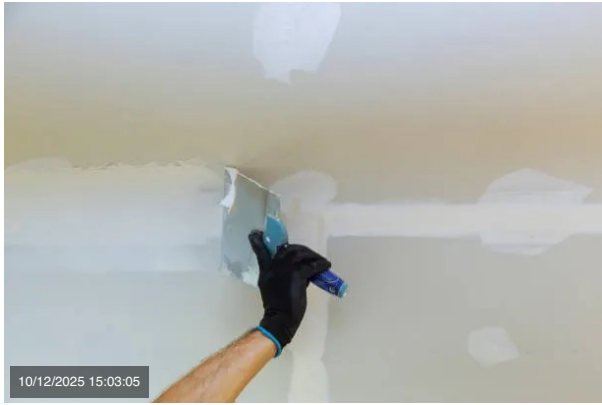
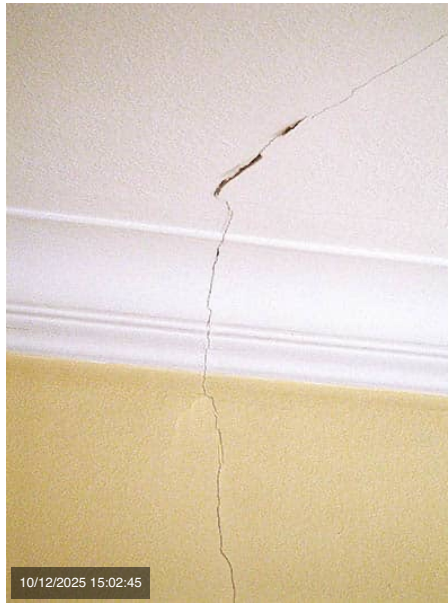
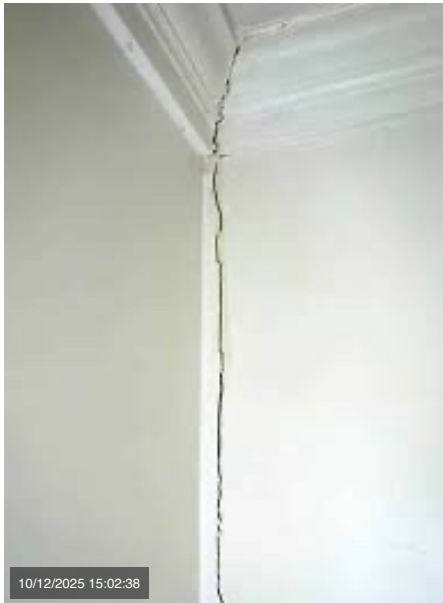
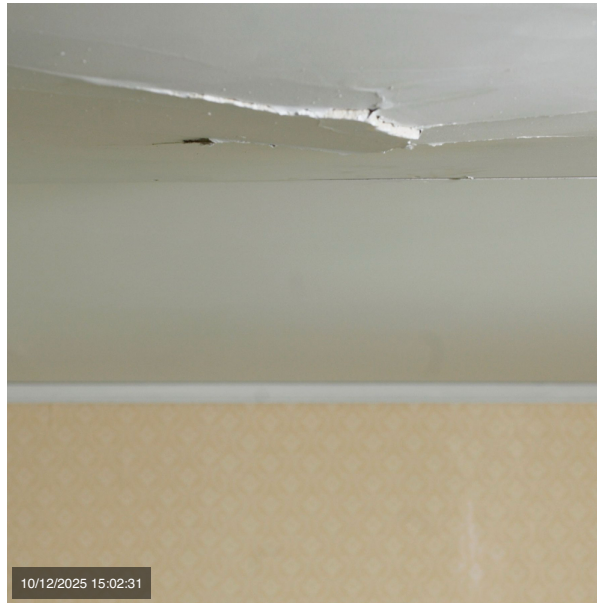
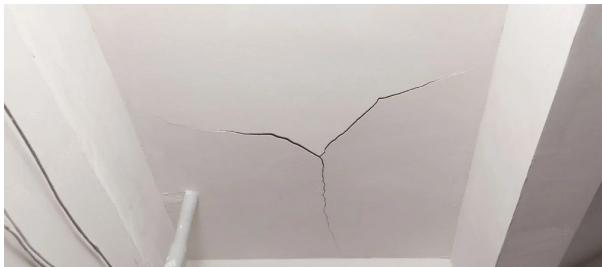
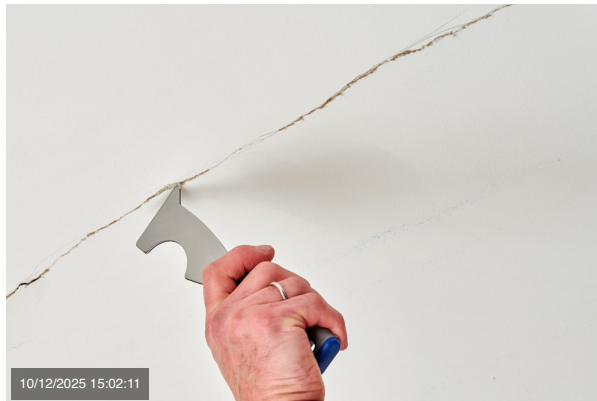
## Ceiling Patch Marks Visible After Repair

The false ceiling shows patchy texture where repair work was carried out. Needs surface sanding and uniform repainting for a smooth finish.

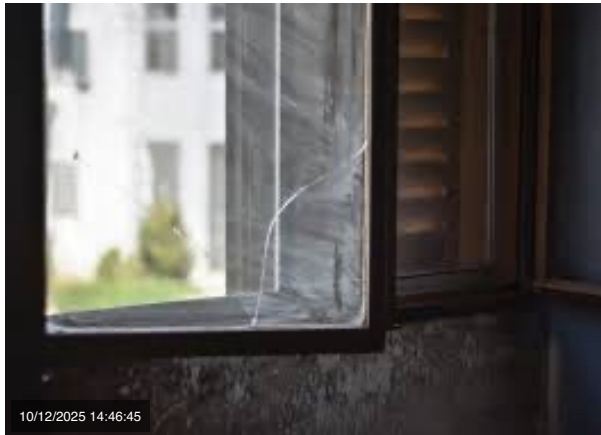
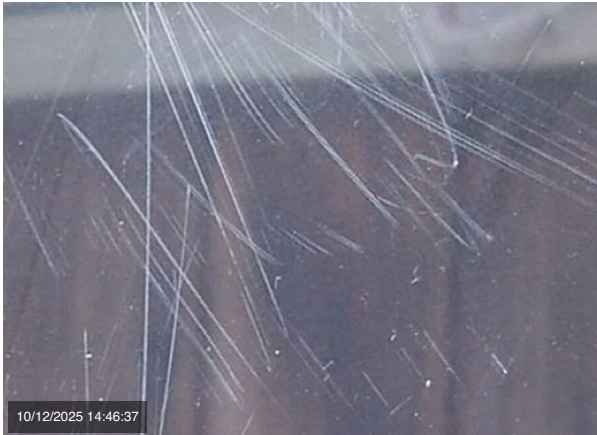
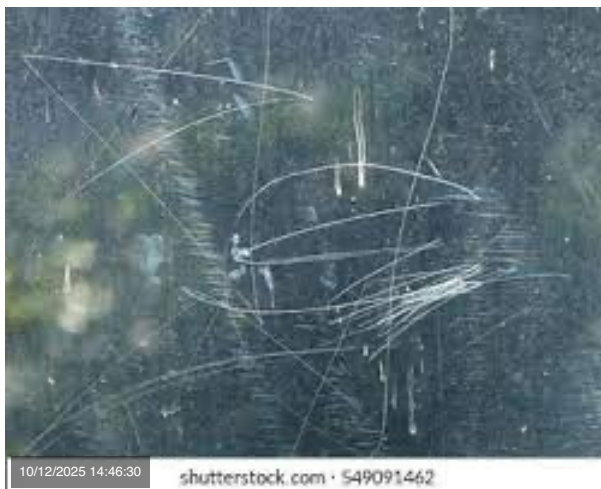
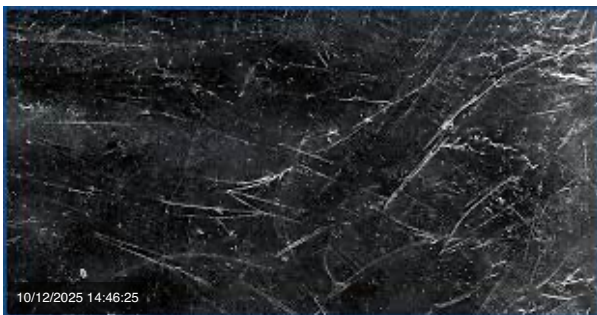
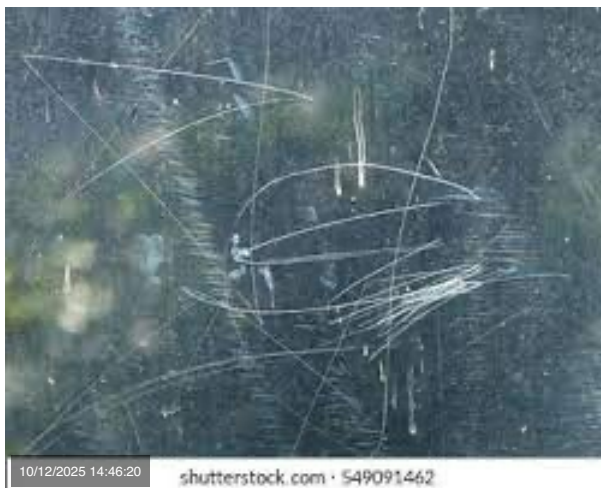
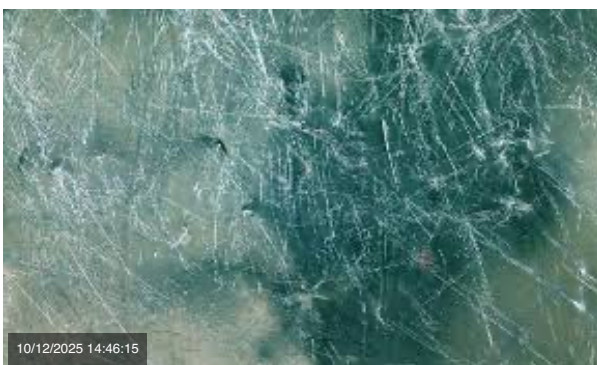
### Bedroom Window Glass Scratched

Sliding glass panel has visible scratches affecting clarity. Replace the damaged panel and verify frame alignment after installation.

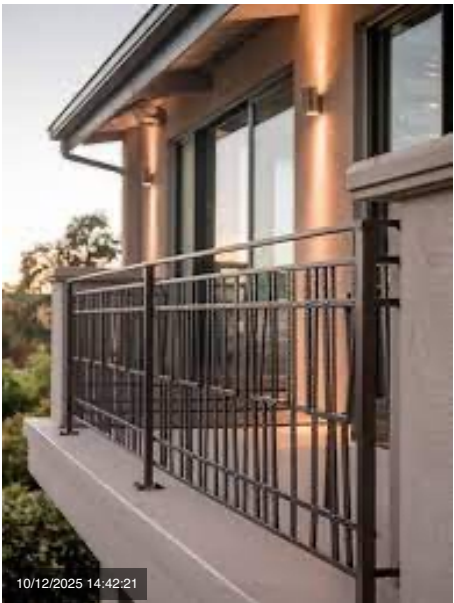
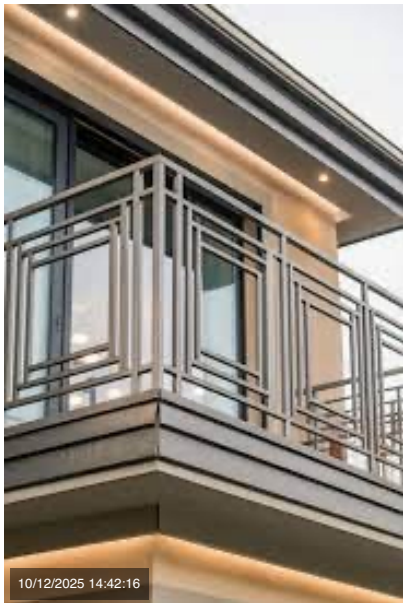
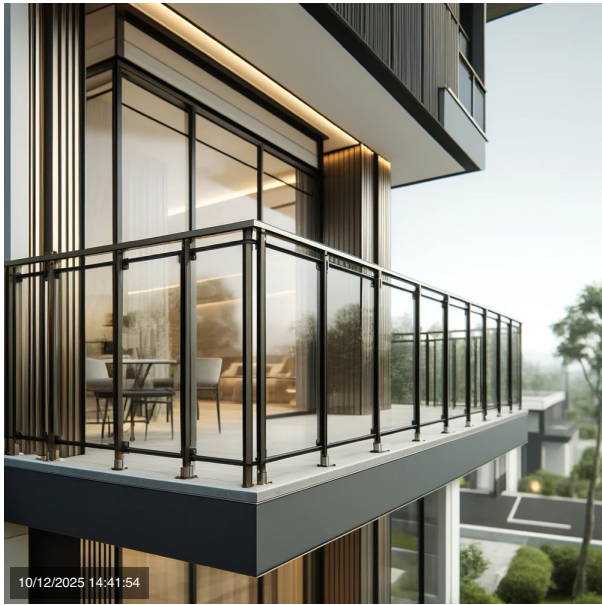
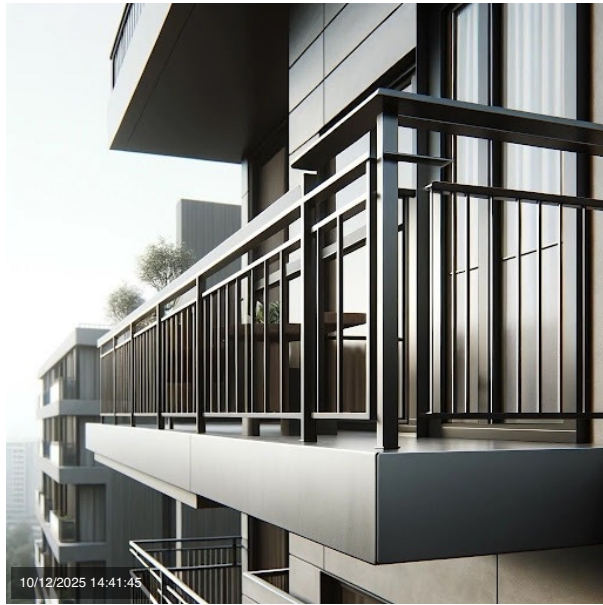
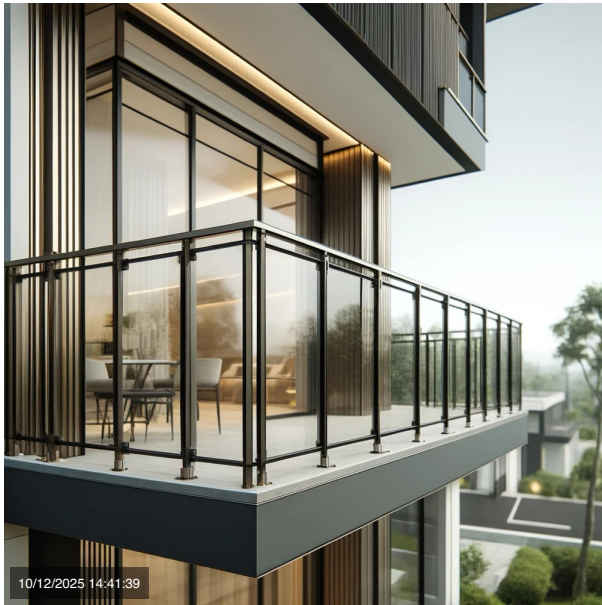
Balcony Railing Found Loose

Balcony railing slightly shakes when leaned on. Base anchoring bolts need tightening and rust protection coating. Safety check mandatory before handover.

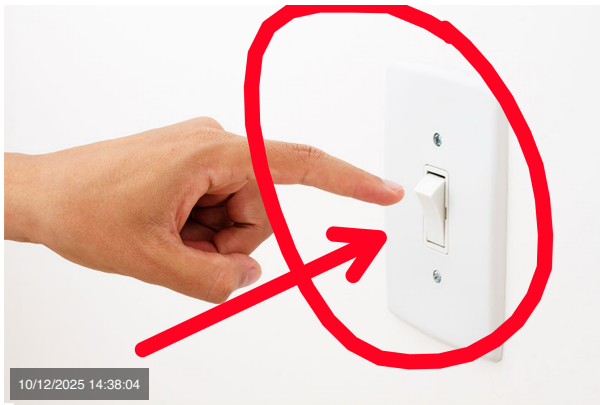
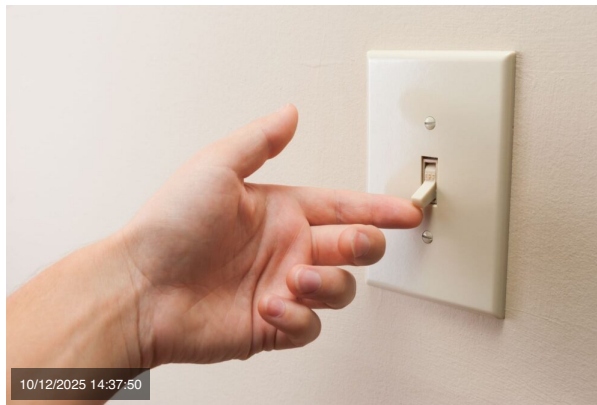
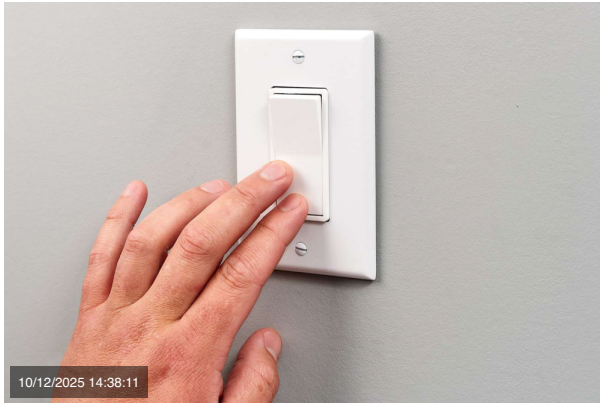
Electrical switch not working

Bedroom switch for ceiling light is non-operational. Possible wiring fault behind switchboard. Requires continuity test and replacement of switch if defective.

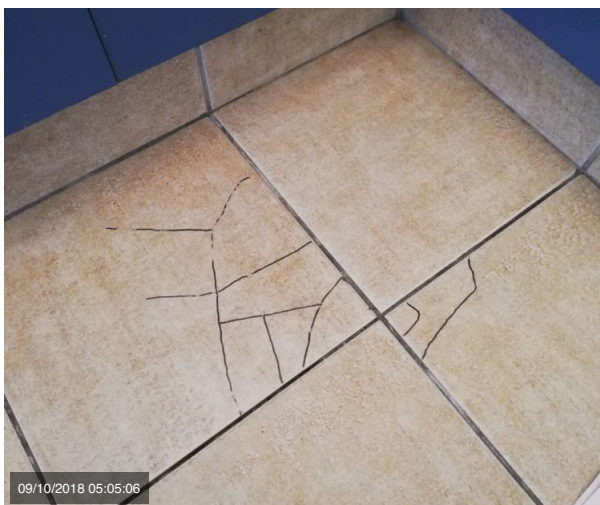
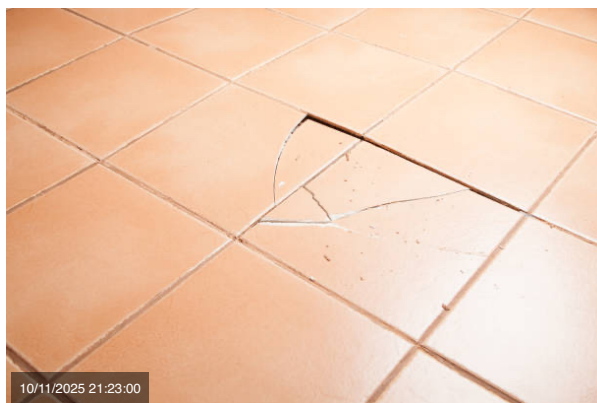
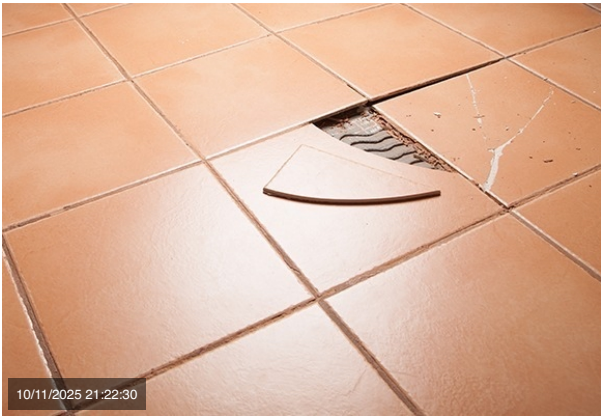
#### Cracked Floor Tile Near Kitchen Entry

One ceramic tile at the kitchen threshold is cracked, likely due to impact during installation. Tile must be replaced and grout color matched.

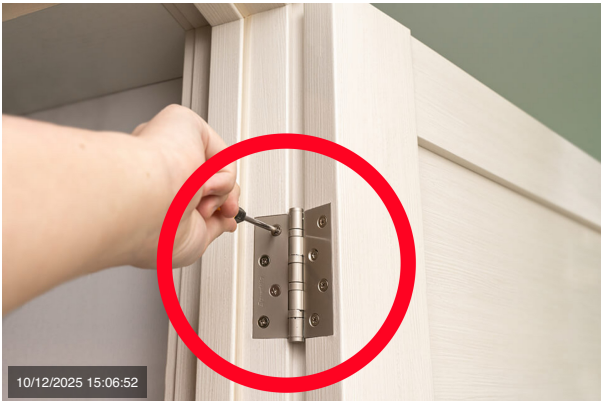
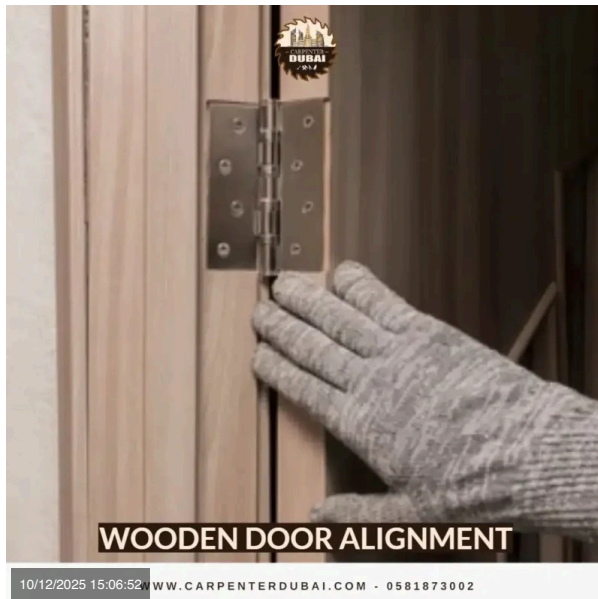
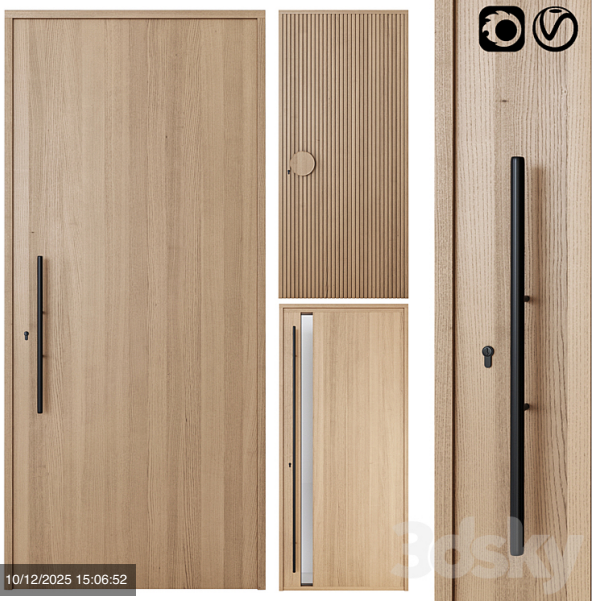
#### Main Door Not Aligned Properly

The main door rubs against the frame and does not latch smoothly. Hinges appear loose and need realignment. Replace rubber beading if required.

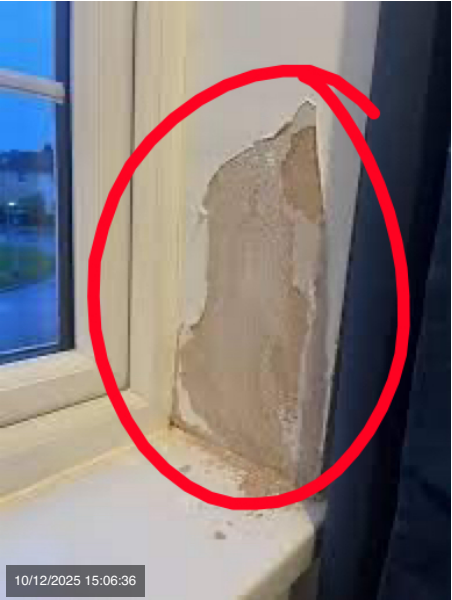
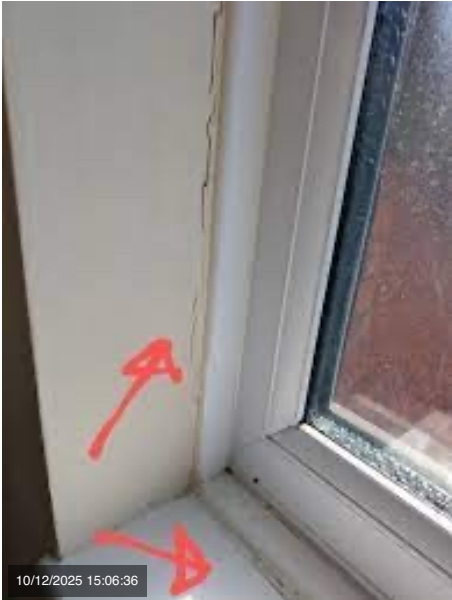
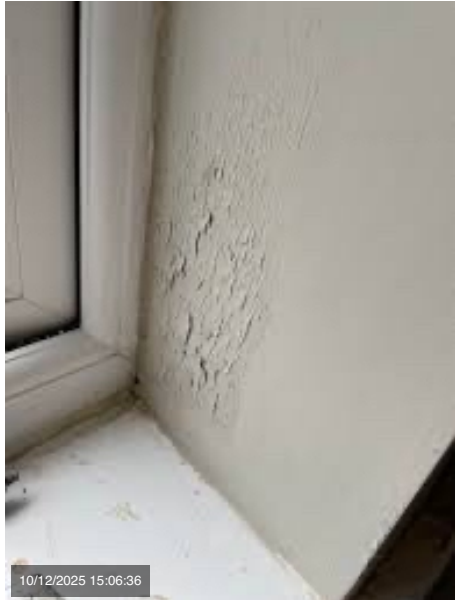
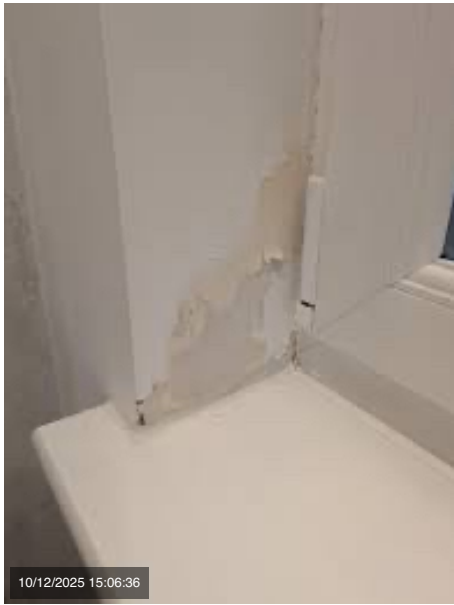
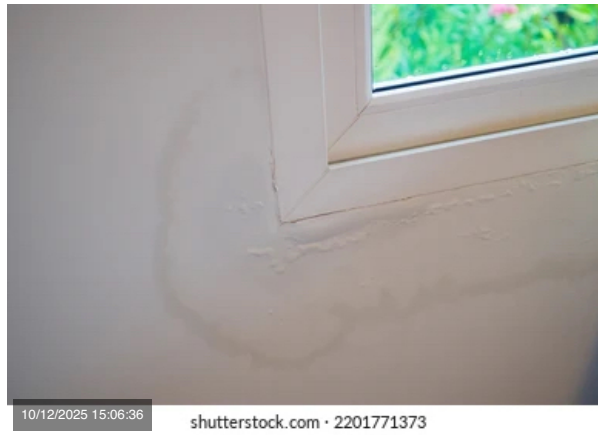
Wall Paint Peeling Near Window Frame

The emulsion paint is peeling off near the living room window, exposing the primer surface. Possible moisture seepage from outer wall detected. Needs repaint and waterproofing check.
