# Residential apartment, Tower-final QA and handover snag list

US-F033-NYC

845 8th Avenue, New York NY 10019, USA

06/15/2025

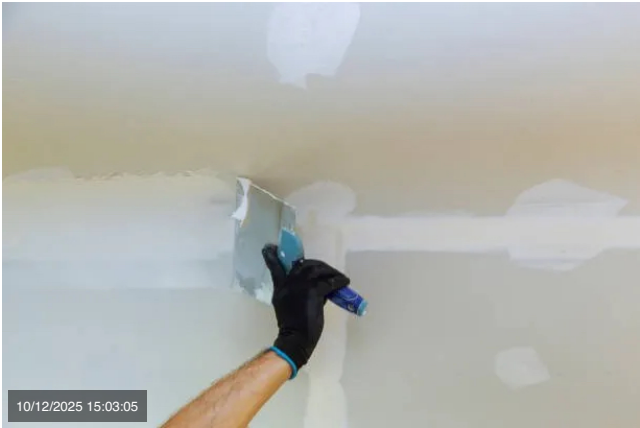
Ceiling Patch Marks Visible After Repair

The false ceiling shows patchy texture where repair work was carried out. Needs surface sanding and uniform repainting for a smooth finish.

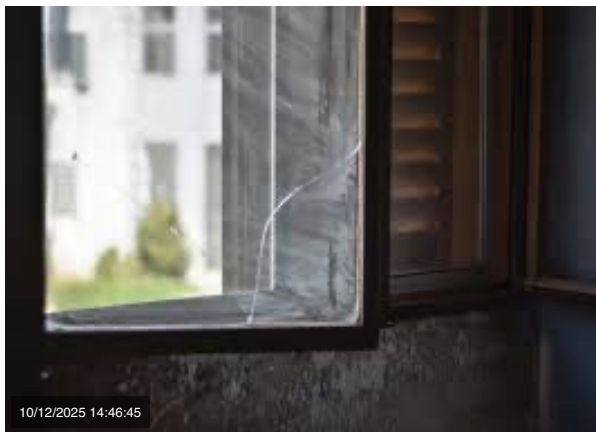
Bedroom Window Glass Scratched

Sliding glass panel has visible scratches affecting clarity. Replace the damaged panel and verify frame alignment after installation.

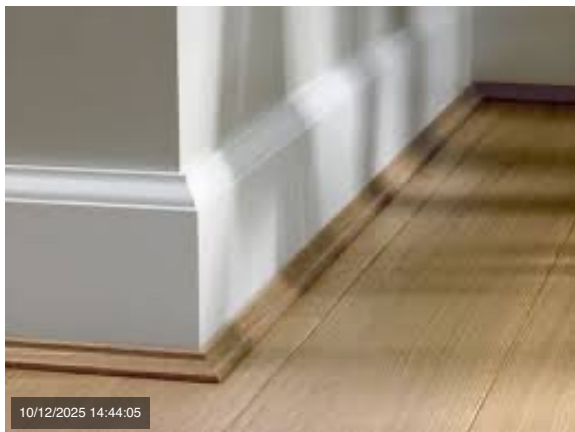
Missing Skirting Board in Living Room

Skirting strip missing along the wall behind sofa placement. Needs installation of matching finish skirting and proper adhesive fixing

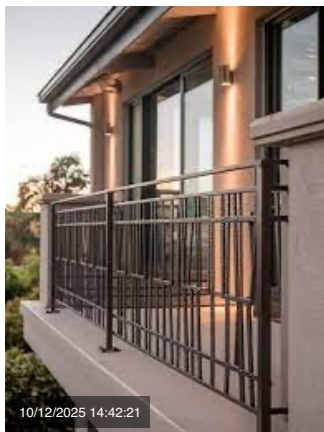
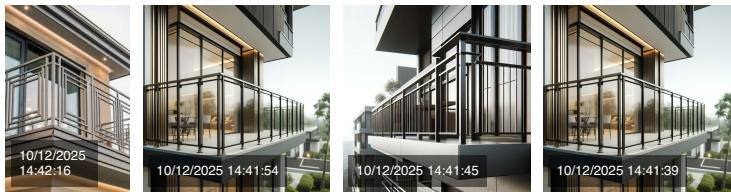
Balcony Railing Found Loose

Balcony railing slightly shakes when leaned on. Base anchoring bolts need tightening and rust protection coating. Safety check mandatory before handover.

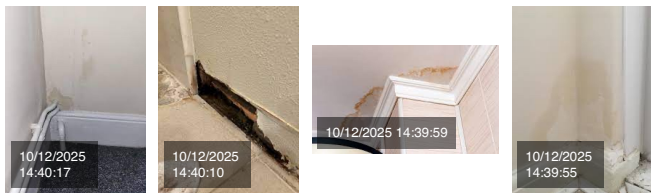
Water Leakage Behind Bathroom Wall

Damp patch observed behind WC area. Suspected leakage from concealed plumbing line. Wall needs inspection, rectification, and retiling after repair.

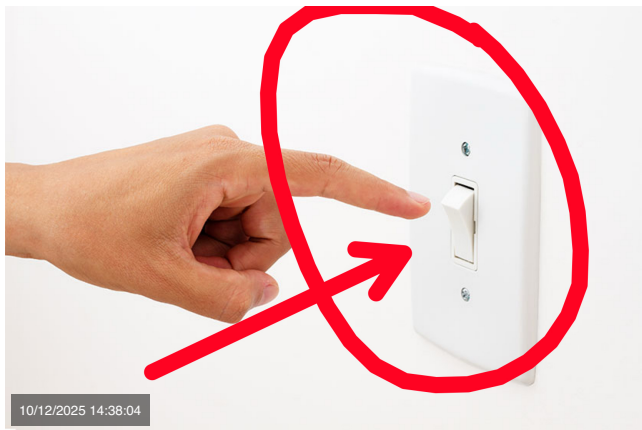
Electrical switch not working

Bedroom switch for ceiling light is non-operational. Possible wiring fault behind switchboard. Requires continuity test and replacement of switch if defective.

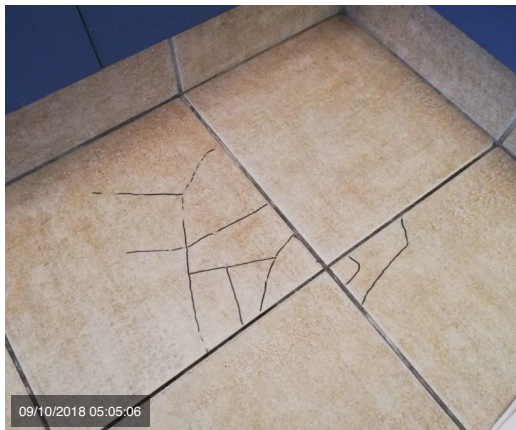
Cracked Floor Tile Near Kitchen Entry

One ceramic tile at the kitchen threshold is cracked, likely due to impact during installation. Tile must be replaced and grout color matched.

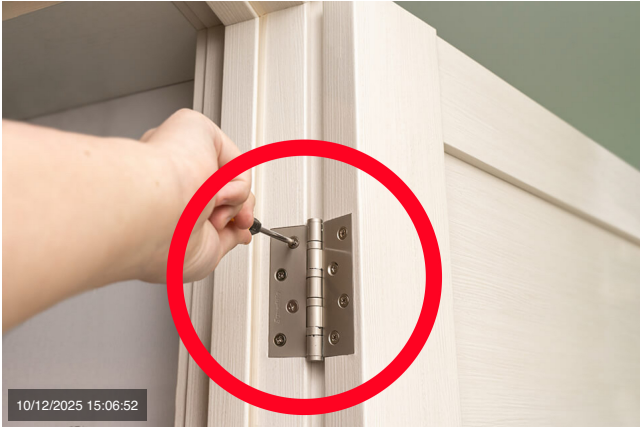
Main Door Not Aligned Properly

The main door rubs against the frame and does not latch smoothly. Hinges appear loose and need realignment. Replace rubber beading if required.

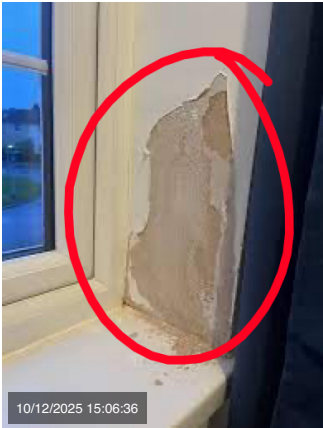
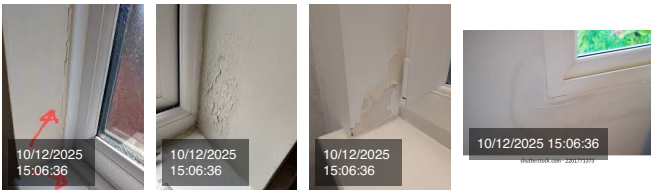
Wall Paint Peeling Near Window Frame

The emulsion paint is peeling off near the living room window, exposing the primer surface. Possible moisture seepage from outer wall detected. Needs repaint and waterproofing check.
